Subsurface Views

Airplane through the Runway

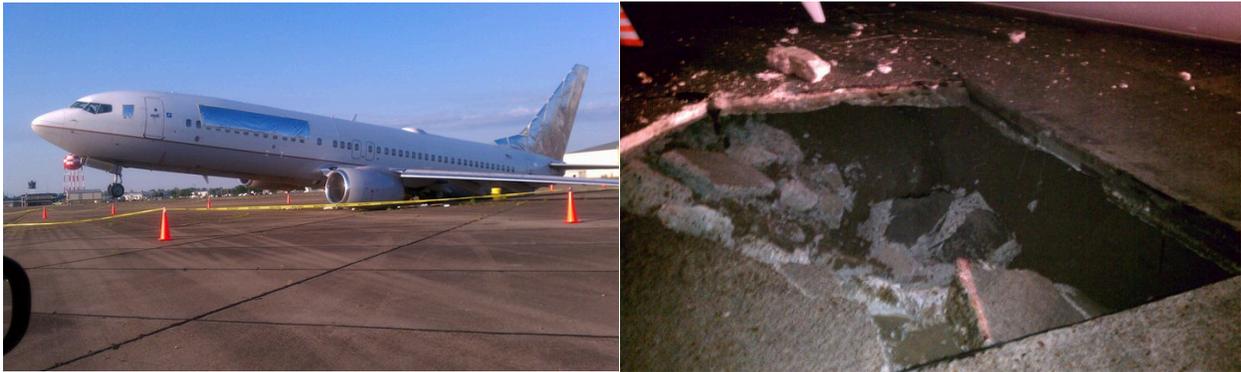
The picture tells the story. Officials at the Mid Delta Regional Airport (former Greenville Air Force Base) in Mississippi were shocked when the wheels of a refurbished Airbus A300 suddenly dropped through the concrete taxiway, causing \$1.5 million damage to the aircraft (Figure 1a left). A large void was discovered underneath the taxiway (Figure 1b right).

Geologists speculated that subsurface processes, associated with the flooding of the nearby Mississippi River the previous spring, caused voids to form under the concrete.

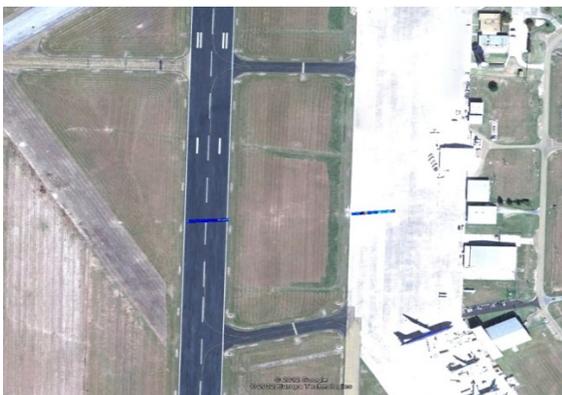
A GPR service provider, TeaCo Geophysical, was hired to demonstrate the efficacy of using GPR for mapping voids. Airport engineers decided to survey 2 areas over top of a 56"-diameter, bricked storm drain that crossed a taxiway and runway; a location they felt would most likely be susceptible to voids (Figure 2).
